Assessing the risk of non-compliant firestopping and smokestopping in New Zealand residential buildings undergoing alterations

Kevin Frank, Greg Baker and Jonathon MacIntyre

BRANZ Study Report SR410

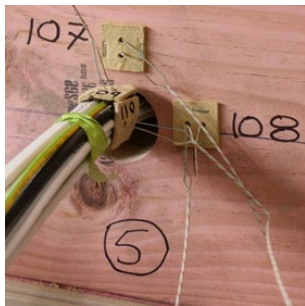
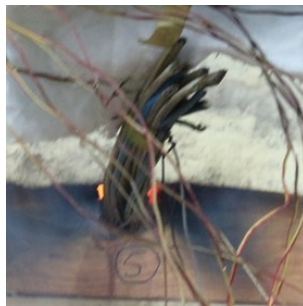
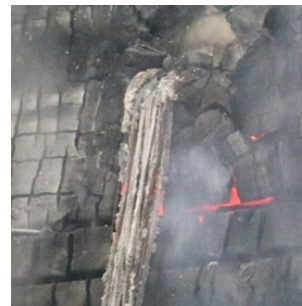
Figure 24. Test TV: 12-cable bundle, 52 mm diameter penetration.

Two 12-cable bundle penetrations were installed without firestopping, one without plasterboard pattresses (Figure 24) and one with (Figure 25). The 52 mm diameter hole size for these penetrations was almost large enough for the penetrations to fail based on the gap gauge before the test started. Both of these penetrations failed insulation quickly, at 3 and 5 minutes respectively. The penetration without a plasterboard pattress reached a peak temperature rise of 625 K on the unexposed side and the one with reached 603 K. Both penetrations also failed integrity before 30 minutes, at 19 and 21 minutes respectively. However, the plasterboard pattress kept the substrate temperature on the unexposed side well below 180 K temperature rise.

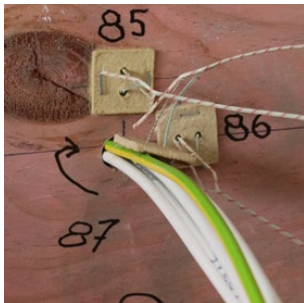
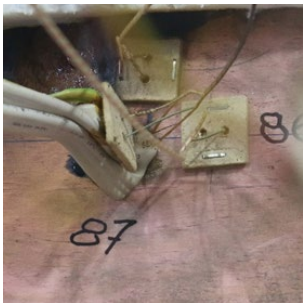
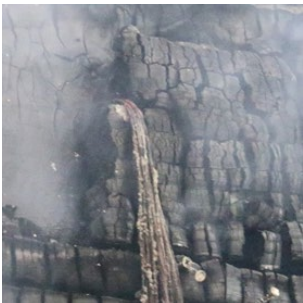
Figure 26. Test TV: 3-cable bundle, 16 mm diameter penetration.

None of the 3-cable or 1-cable unsealed penetrations (Figure 26–Figure 29) failed insulation or integrity prior to 60 minutes in this substrate. Very little charring was observed on the unexposed side of these penetrations as well.

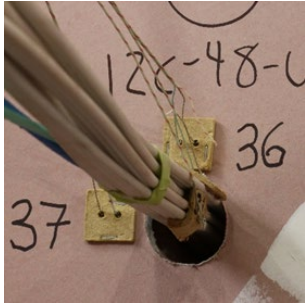
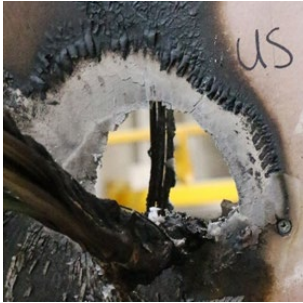
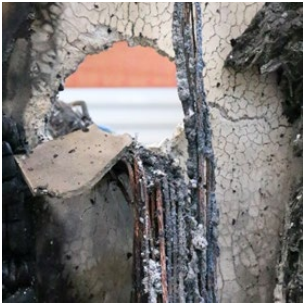
Figure 30. Test CV: 12-cable bundle, 48 mm diameter penetration.

One 12-cable bundle penetration was installed in the fibre-cement board wall without firestopping (Figure 30). It failed insulation at 19 minutes and integrity at 27 minutes, with one thermocouple recording a maximum temperature rise of 786 K. The substrate was severely damaged on both sides, and the cable insulation on the unexposed side was severely charred.

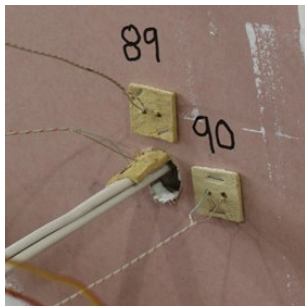
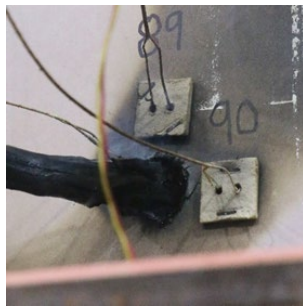
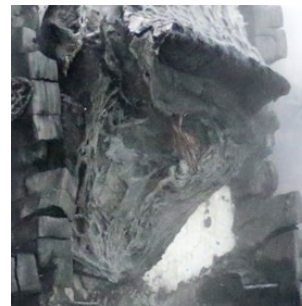
Figure 31. Test CV: 3-cable bundle, 25 mm diameter penetration.

3-cable bundles were installed with penetration diameters of 25 mm, 18 mm and 16 mm (Figure 31–Figure 33). All failed insulation at 29, 48 and 49 minutes respectively. Maximum temperature rises of 348 K, 278 K and 373 K were recorded, respectively. None of these penetrations failed integrity, and the 25 mm and 18 mm penetrations were particularly charred.

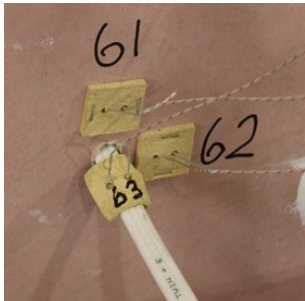
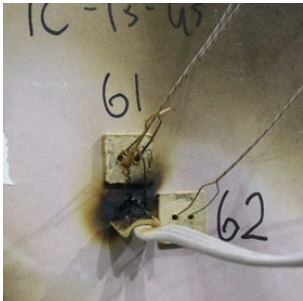
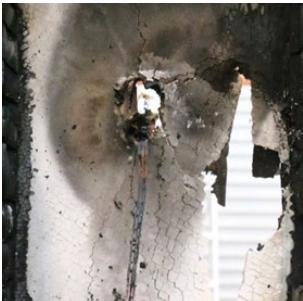
Figure 34. Test CV: 1-cable, 13 mm diameter penetration.

One 1-cable penetration with a penetration diameter of 13 mm was installed in the fibre-cement board wall. It failed insulation at 58 minutes and did not fail integrity. Some charring was noted (Figure 34).

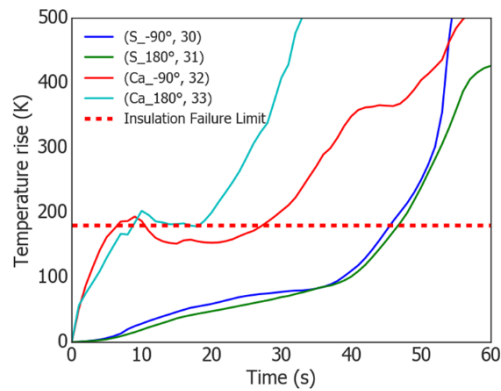
Figure 35. Test PH: 12-cable bundle, 44 mm diameter penetration.

The single unsealed 12-cable bundle installed in a 44 mm diameter penetration (Figure 35) failed insulation at 7 minutes and integrity at 55 minutes. The peak temperature rise recorded was 676 K. The unexposed side was substantially charred.

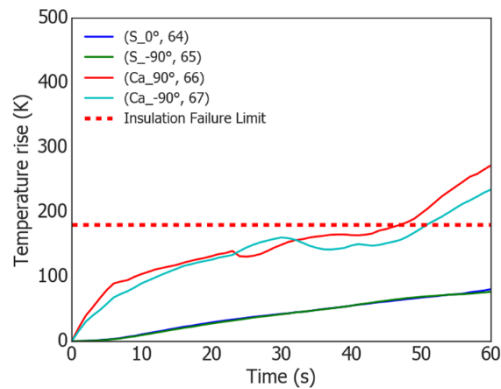
Figure 36. Test PH: 3-cable bundle, 25 mm diameter penetration.

Of the three 3-cable bundles installed in 25 mm, 18 mm and 16 mm diameter penetrations (Figure 36–Figure 38) only the 25 mm penetration failed insulation before the test completed, at 48 minutes. The peak temperature rise recorded for this penetration was 272 K. No integrity failures were observed for these penetrations. Substantial charring was observed near the 25 mm diameter penetration, light charring was noted near the 18 mm diameter penetration and nearly no charring was noted around the 16 mm penetration.

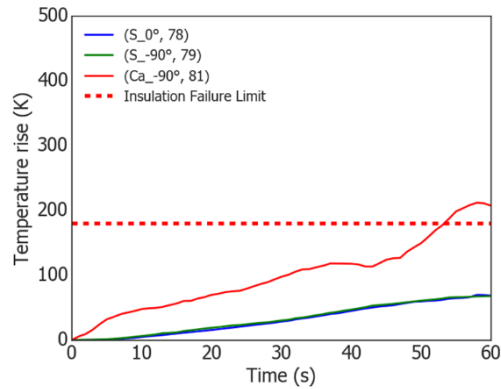
Figure 39. Test PH: 1-cable, 16 mm diameter penetration.

Single cables were installed in 16 mm and 13 mm diameter unsealed penetrations (Figure 39 and Figure 40). The 16 mm diameter penetration failed insulation at 54 minutes, with a peak temperature rise measured of 212 K. The 13 mm diameter penetration did not fail on insulation. Neither 1-cable penetration failed integrity prior to the end of the test. The cable insulation on the unexposed side of the 16 mm diameter penetration was substantially charred.

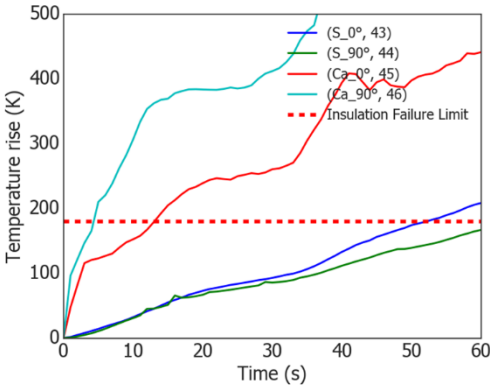
Figure 41. Test CH: 12-cable bundle, 47 mm diameter penetration.

A 12-cable bundle in a 47 mm diameter unsealed penetration (Figure 41) failed on insulation at 5 minutes, with a peak temperature rise of 702 K. It failed on integrity at 33 minutes, and the unexposed side cable insulation was substantially charred.

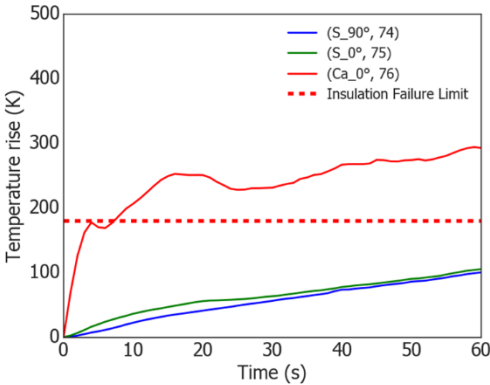
Figure 42. Test CH: 3-cable bundle, 24 mm diameter penetration.

3-cable bundles were installed in 24, 18 and 16 mm diameter penetrations (Figure 42–Figure 44). The 24 mm diameter penetration was the only one that failed on insulation, at 8 minutes. The maximum temperature rise recorded on this penetration was 294 K. None of the 3-cable bundle penetrations in this substrate failed integrity before the end of the test. The cable insulation was substantially charred on the unexposed side of the 24 mm diameter penetration, while charring was minimal on the unexposed side of the 18 mm and 16 mm diameter penetrations.

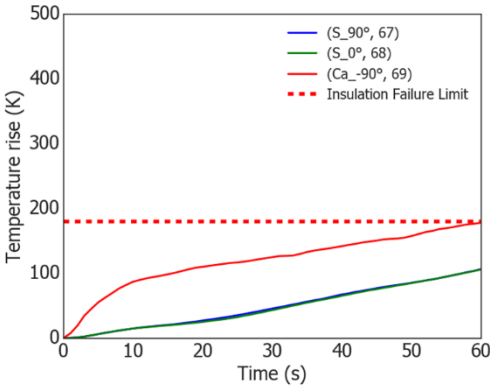
Figure 45. Test CH: 1-cable, 16 mm diameter penetration.

Neither the 16 mm or 12 mm diameter 1-cable penetrations failed either insulation or integrity in the timber infill floor substrate (Figure 45 and Figure 46). The cable insulation was charred on the unexposed side of the 16 mm diameter penetration.

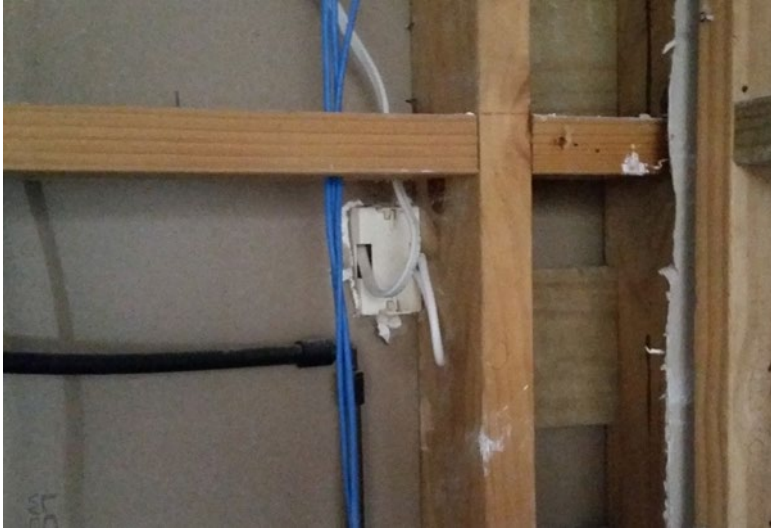
Figure 61. Unrated flush boxes in fire-rated walls.

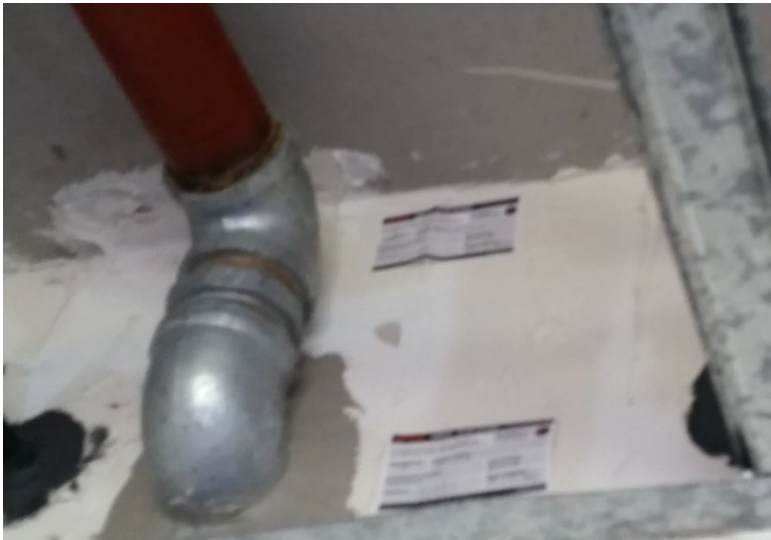
Figure 62. Penetrations through fire walls sealed with smoke seal only.

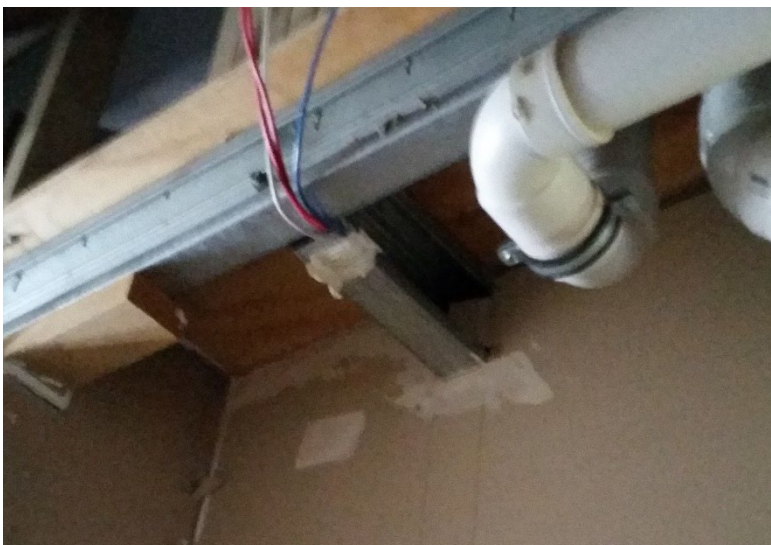
Figure 63. Non-sealed structural steel penetration of a fire-rated wall.

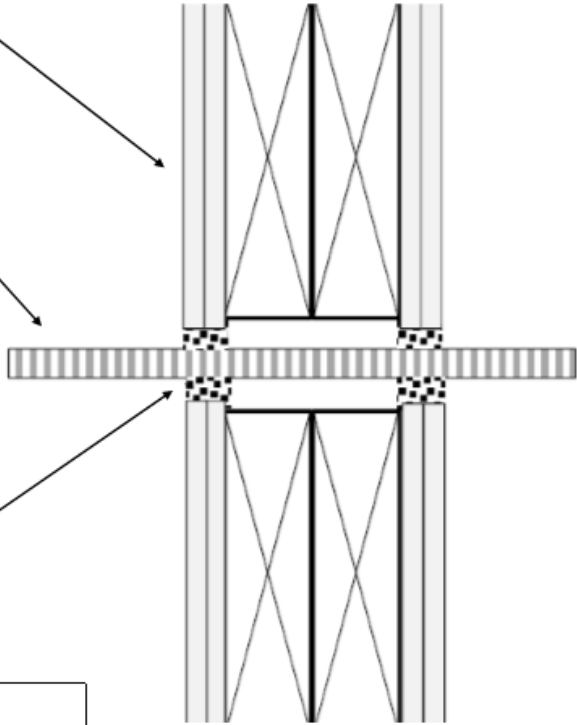
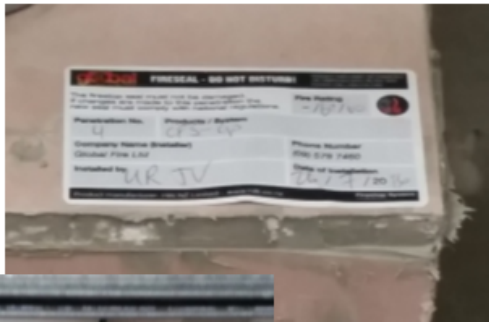
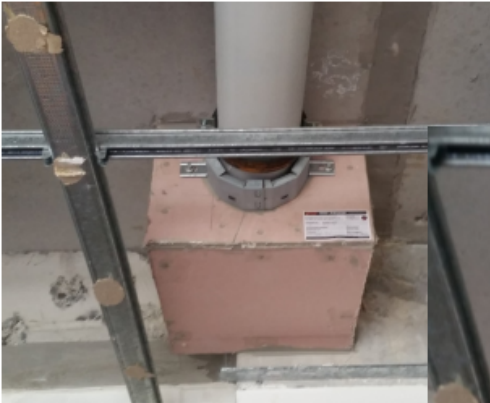
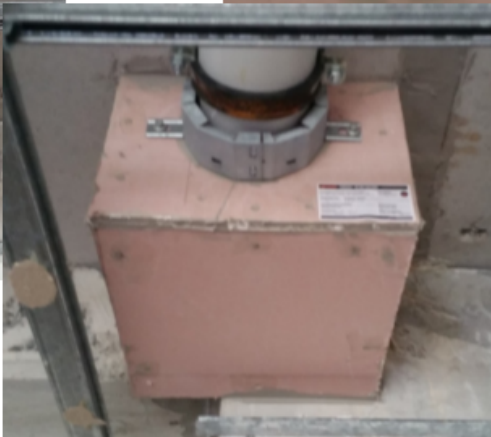
Sketch Number: 04

Sealant Details: None

Comments:
Plasterboard bulkhead box attached to concrete wall

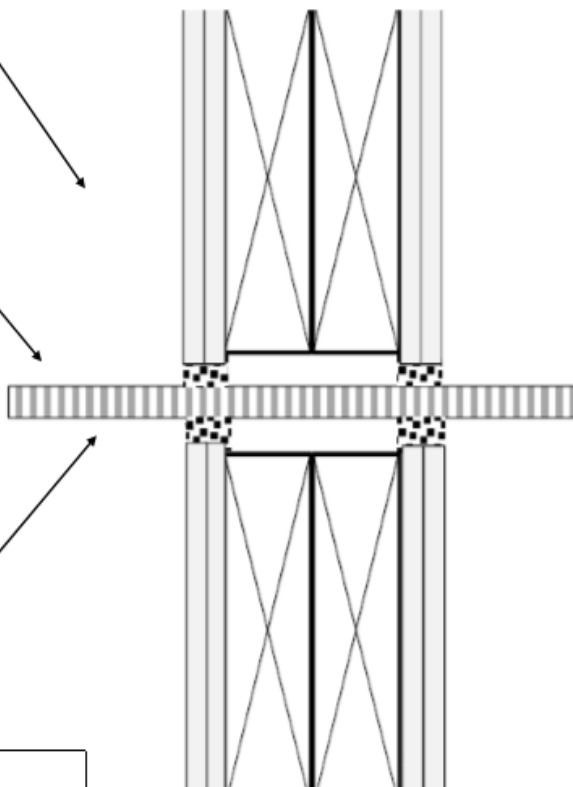
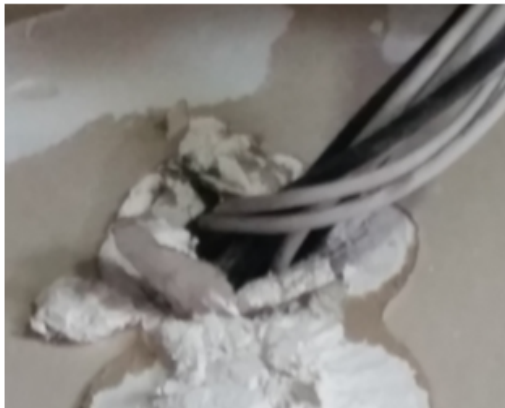
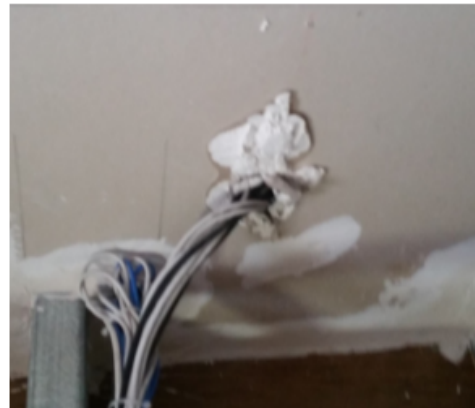
<p>Sketch Number: 05</p> <p>Location: Lvl 7 Corridor (Means of Escape)</p>	<p>Cavity Details:</p> <p>None Recorded/apparent</p> <p>Penetration in IT wall above ceiling height</p>

<p>Wall Lining Type: Gypsum Plasterboard - Standard (appears)</p> <p>Thickness: 13mm</p>	
<p>Penetration Type: Cable</p> <p>Penetration Diameter: 5-7 mm x 7-9</p> <p>Hole Details: 60 mm Rough hole (made with hammer blow)</p>	
<p>PFP System: None</p> <p>Sealant Details: None</p>	
<p>Comments:</p> <p>Corridor wall into apartment</p>

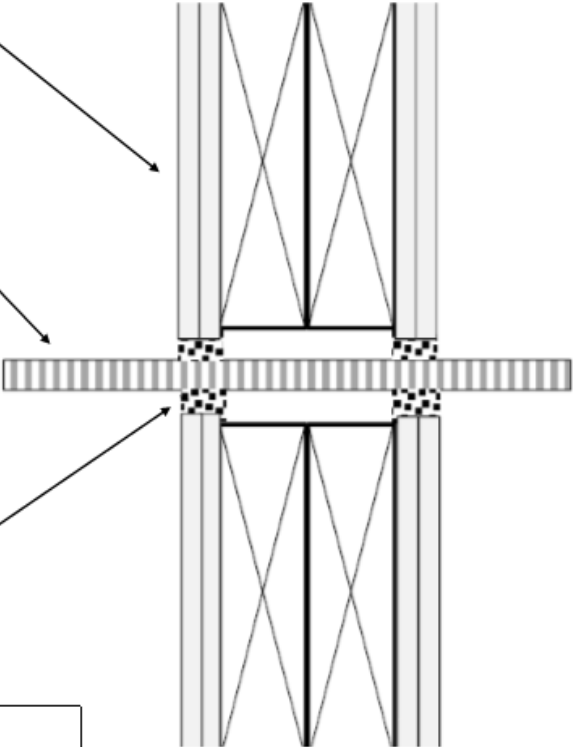
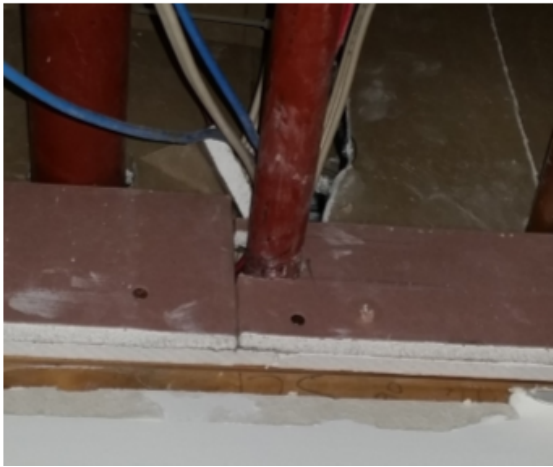
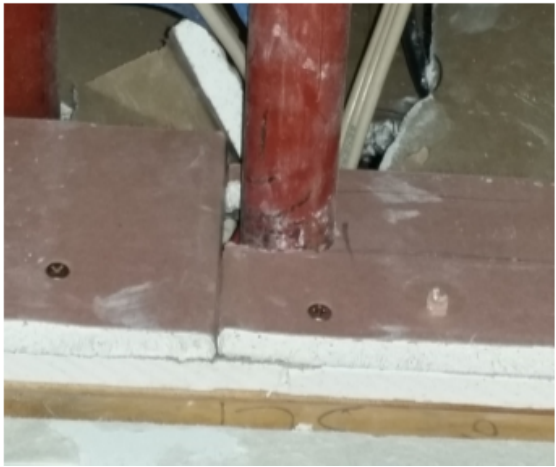
<p>Sketch Number: 07</p> <p>Location: Lvl 7 Corridor (Means of Escape)</p>

<p>Cavity Details:</p> <p>None Recorded/apparent</p> <p>Penetration in IT wall above ceiling height</p>
<p>Wall Lining Type: Gypsum Plasterboard - Standard + fire-rated Pattress</p> <p>Thickness: 2 x 13mm</p>		
<p>Penetration Type: Sprinkler Pipe</p> <p>Penetration Diameter: 35 mm</p> <p>Hole Details: 40 mm</p>		
<p>PFP System: None</p> <p>Sealant Details: None</p>		
<p>Comments:</p> <p>Corridor wall into apartment</p> <p>Pattress appears to end within 10-20 mm of top of penetration. Penetration on edge of sheet, join is not stopped</p>

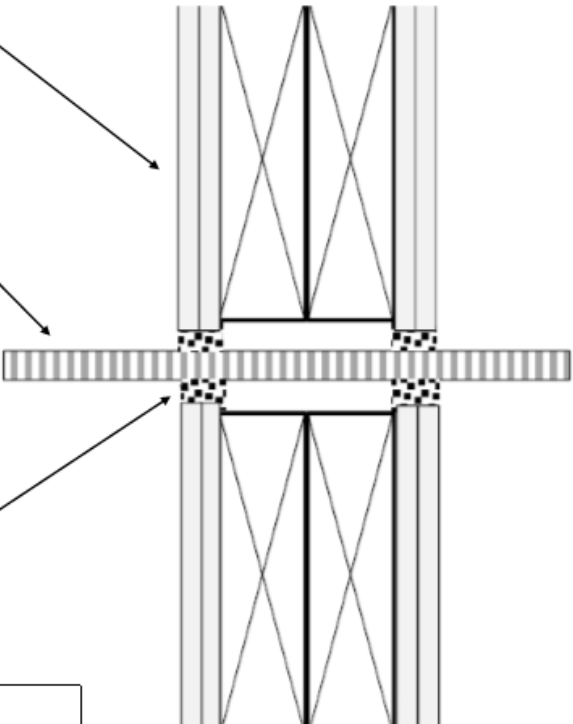
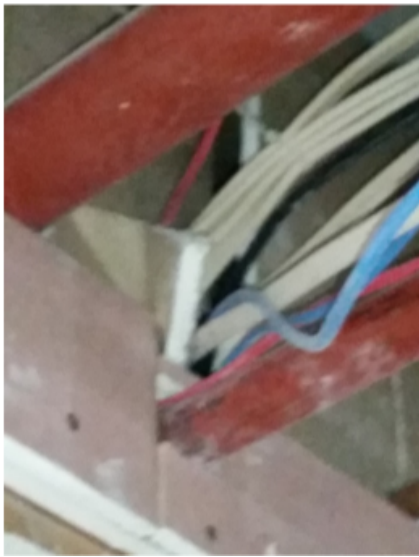
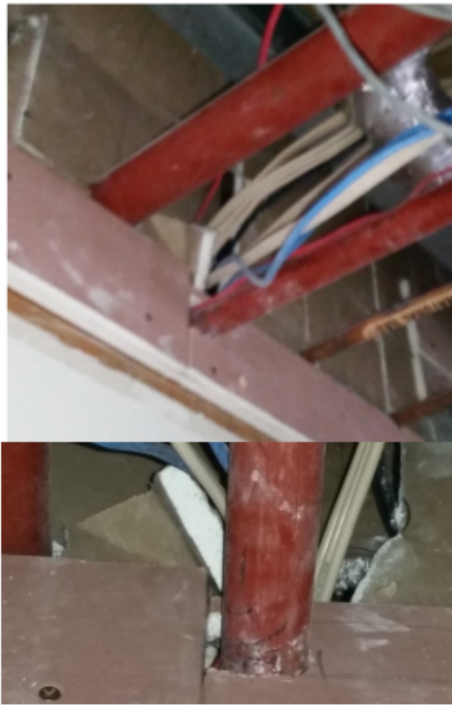
Sketch Number: 07a

Hole Details: Cables penetrating through broken section of plasterboard

Plasterboard is broken and unstopped in surrounding area

Penetration in IT wall above ceiling height

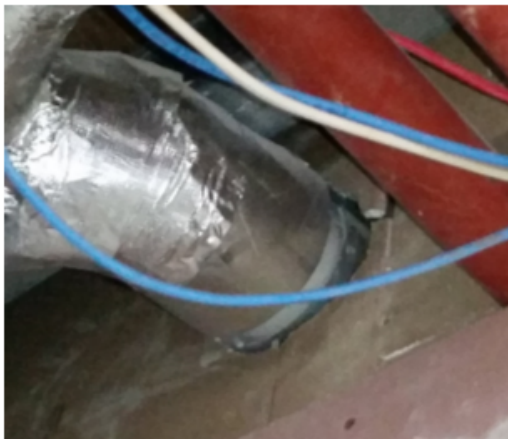
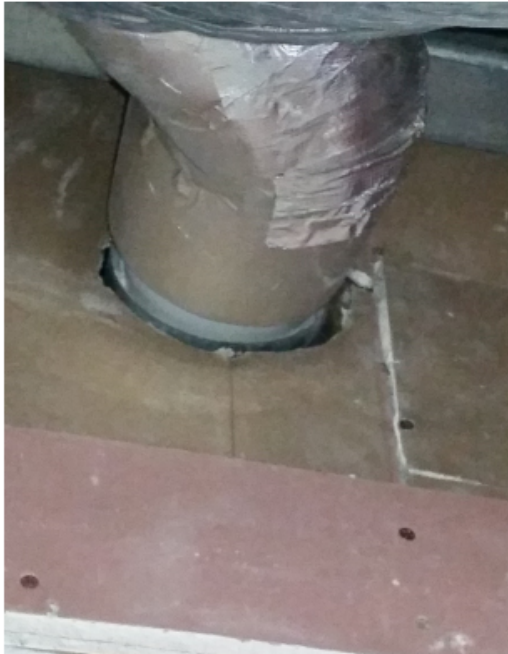
<p>Sketch Number: 08</p> <p>Location: Corridor (Means of Escape)</p>

<p>Cavity Details:</p> <p>None Recorded/apparent</p>
<p>Wall Lining Type: Gypsum Plasterboard - Standard (appears)</p> <p>Thickness: 1 x 13mm</p>		
<p>Penetration Type: uPVC Pipe</p> <p>Penetration Diameter: 110 mm Pipe in 120mm Sleeve</p> <p>Hole Details: 140mm</p>		
<p>PFP System: Wrap</p> <p>Sealant Details: None</p>		
<p>Comments:</p> <p>Corridor wall into apartment</p>

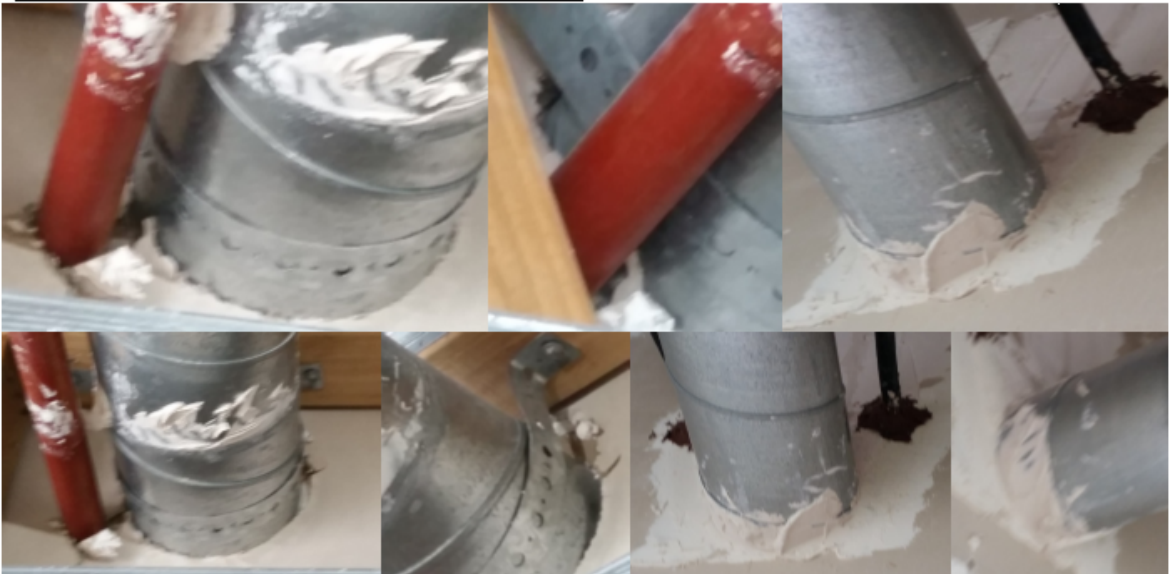
Sketch Number: 09

Cavity Details: None Recorded/apparent
Location: Corridor (Means of Escape)		
Wall Lining Type: Gypsum Plasterboard - Standard (appears)		
Thickness: 2 x 13mm		
Penetration Type: Non-combustible duct		
Penetration Diameter: 150 mm		
Hole Details: 160mm		
PFP System: See Comments		
Sealant Details: None		
Comments: Corridor wall into apartment. Two ducts observed. The first was unsealed and the second has stopping around the penetration (no label to identify if the stopping material is fire rated).

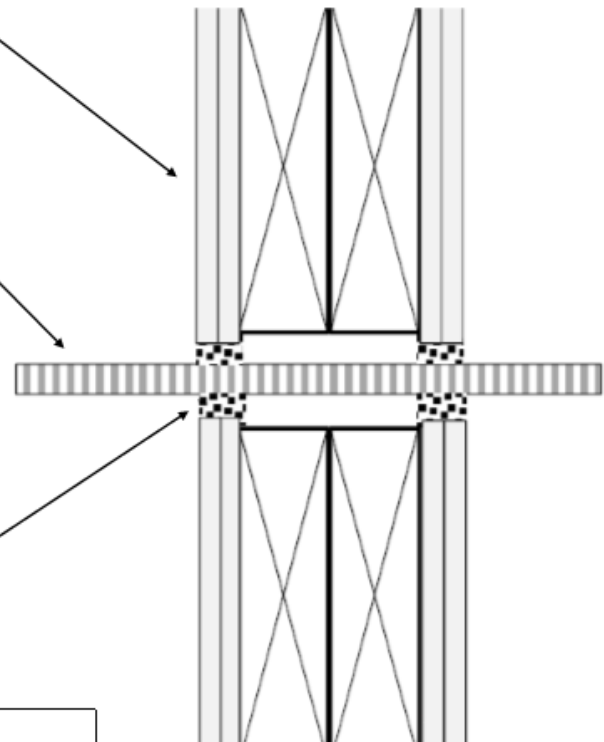
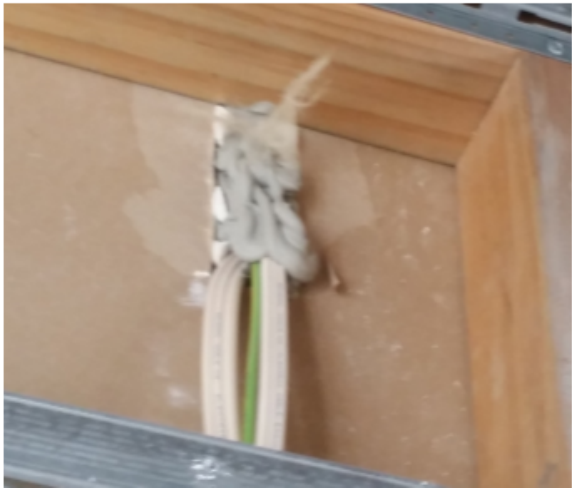
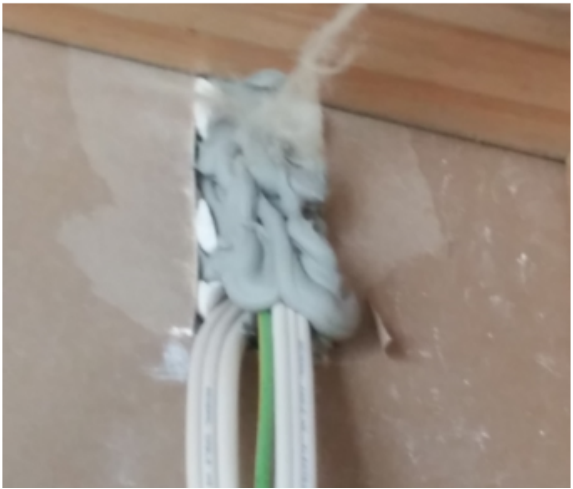
Sketch Number: 10

One sided wall lining

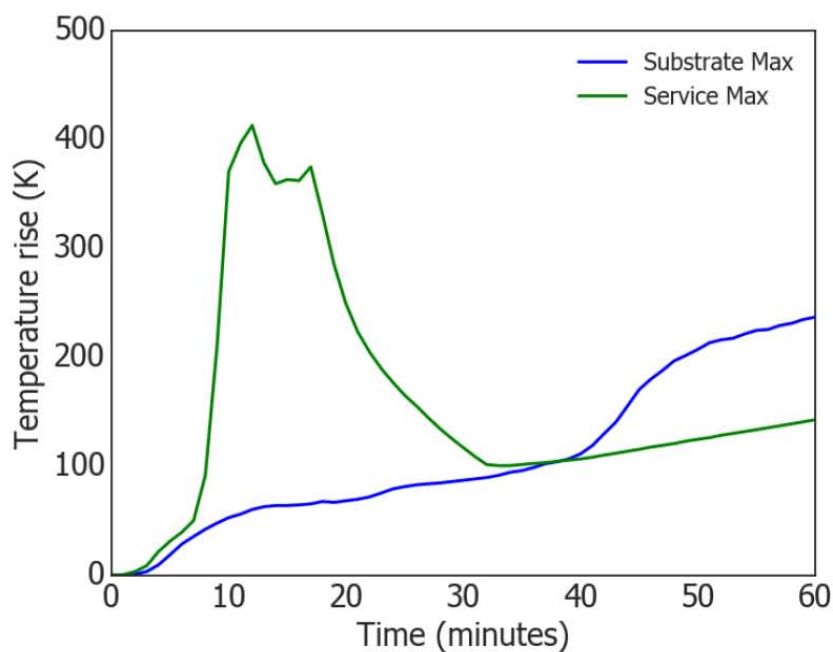
Figure 1: Penetration A thermocouple temperatures

Observations related to the integrity performance of the specimens were made during the test. A 25 mm gap gauge could be projected into the furnace through Penetration A at 14 minutes and a cotton pad was ignited at Penetration F at 10 minutes. No significant integrity observations were made during the test duration for the other penetrations.
